## **“FAMILIARITY BREEDS CONTEMPT” - THE NEED TO ENGINEER PASSIVE DEVICE TECHNOLOGY TO MINIMIZE HUMAN INTERACTION IN SAFETY PROCESSES**

Andrew Abrams, Thomas Steinbach, Joseph Abrams

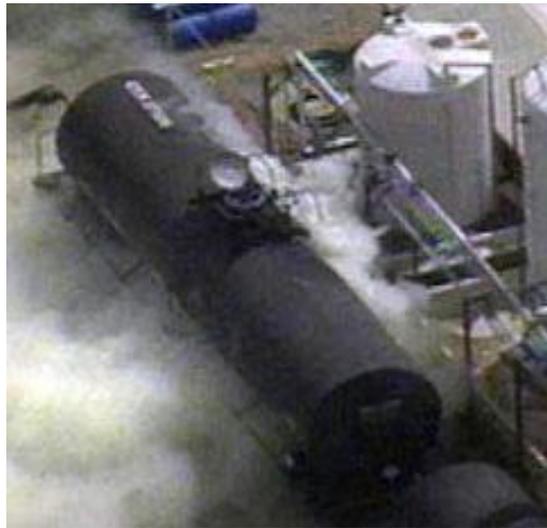
DPC Chemical, Festus, Missouri August 2003

A chlorine repacking plant receives 4 railcars contained nearly 250,000 lbs of chlorine to be repacked into cylinders and other distribution. After 59 days, a hose wrongfully identified as a chlorine hose catastrophically failed spilling 48,000 pounds of Chlorine over 3 ½ hours. The root cause in addition to the hose failure, is that backup systems (ESD'S) as well as Excess Flow Valves (EFV's) failed to work./5/

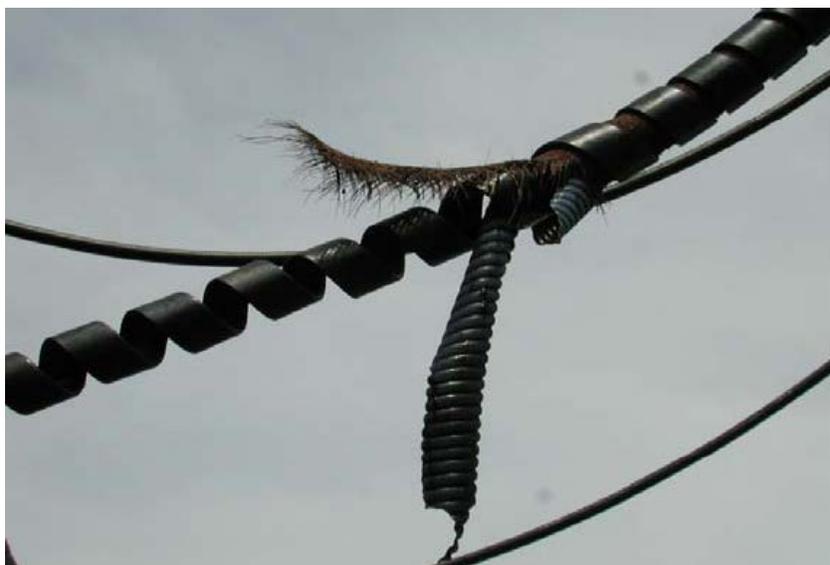
Below is the section of the hose that failed after three workers on break heard a loud “pop”, which clearly was this hose failing. The hose was made of stainless steel not suitable for Chlorine uses, although it was identified as hastelloy by the manufacturer, a material that is suitable for Chlorine usage. There is no visual difference between stainless steel and hastelloy,

therefore the chlorine repackagers employees relied upon the manufacturers representation that they were indeed shipped the correct hose. Moreover, the facility relied upon the four valves (ESDs and Excess Flow Valves) in case of this precise type of error.

Ruptured chlorine transfer hose with its Teflon inner layer exposed; when the hose burst it ejected pieces of Teflon as well as other components of the hose.

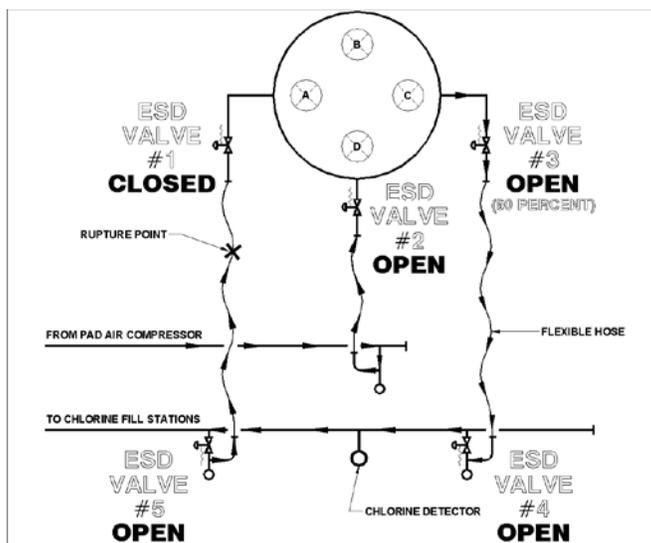
The illustration below shows the positions of all valves and hoses as it relates to this incident. Determining the actual positioning of the five ESD valves at tank car station #3 led the United States Chemical Safety Board's investigators to conclude that the chlorine flowed through the partially opened ESD valve #3, to the attached intact liquid CTH line, into the plant side piping, and back through the ruptured hose (see arrows denoting product path). Closing tank car valve A did not stop the release because valve C continued to supply chlorine through the intact liquid CTH line. Even if these events replayed themselves the product flowing through the building because of the failure of the ESD's would have been stopped by known passive device technology.. This technology would have effectively shut the system down between ESD's 1 & 5 or at the hose connection points. The pressure of the product itself would have kept the plunger/valve sealed and limited loss of product to what was in the hose, likely below the RQ (reportable quantity).

1. The employees moved their hazmat suits which would have allowed them to shut off the chlorine via valves on the car to an area near the door leading to the car. The chlorine enveloped these suits early in the incident making them inaccessible and thus eliminating this remedy. This was a direct violation of established and known company policy. The flow was eventually stopped at the railcar by independent emergency responders 3 ½ hours later in the exact same hazmat suits.
2. Upon realizing that they could not reach their hazmat suits the employees evacuated. Upon leaving the building they activated the remotely operated emergency shutdown devices, the switch went from "open to closed" as it head

during regular testing of the switch. However, nobody had inspected the actual valving to see if they were closing per the command, they were not closing. This lack of regular inspection of the ESD's themselves was in direct violation of company requirements of regular equipment functionality inspections.

3. The operators of this plant relied upon EFV's to recognize hose failure as excess flow which the EFV's were not and have not been designed to do.

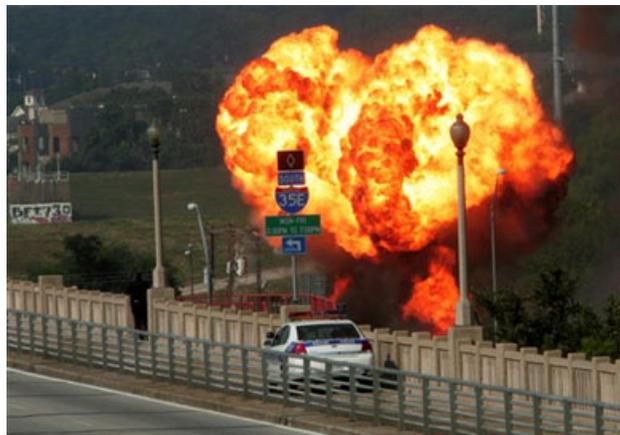
4. Fire officials have said the hose connection between the driver, Mr. McDonald's truck and the larger, stationary tanks suffered a "catastrophic failure" and the escaping gas was apparently ignited by a furnace inside the nearby foundry unleashing a tower of fire into the sky and spewing truck pieces around the foundry. Three others had minor injuries and were treated and released at Tacoma-area hospitals. Mr. McDonald passed away on Sunday, October 14.

1. The operator in a hurry and behind schedule decided not to use the hose equipped with a passive device which was on his delivery truck. This is a direct violation of his company's policies his training (terminable offense) and a violation of United States law.
2. Two facility workers assisted Mr. McDonald in putting an unsafe fitting onto an unsafe hose for the product transfer. This is a direct violation of their company's policies, their training and United States law.
3. The delivery truck was equipped with which were the last line of defense once the passive device equipped hose was not used and failed to recognize the hose failure as

excess flow allowing product to escape unimpeded from the truck which eventually ignited killing the driver and destroying the facility.

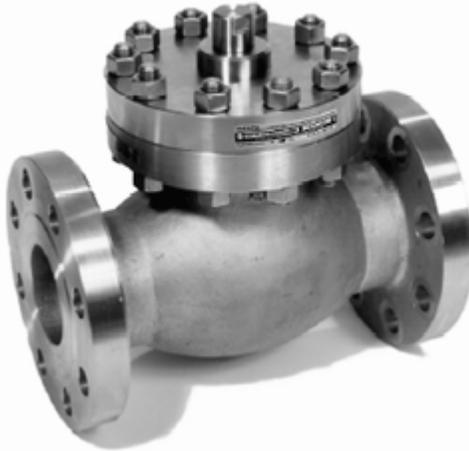
An excess flow valve is, typically, a metallic device inserted into the interior piping of a tank car, just below the valve(s) used to load and unload the car. In the event that the valves are sheared off in a railroad accident, there will be a sudden rush of product out the opening thus created. With nothing to impede the flow of fluid product, the excess flow valve will move toward the opening and seat, thus sealing off the opening. In response to concerns that the then-current regulatory provision for excess flow valves might be ambiguous, in 1985 the DOT published a notice of proposed rulemaking to amend the tank car specifications by adopting what is now the contemporary standard. Proponents of the clarification stated that tank-mounted excess flow valves are not intended to substitute for adequate excess flow equipment in plant loading systems. ``The only use of such valves is for protection against loss of lading due to shearing of external closure during transit." \2\

Excess flow valves, by their nature, must encounter a high-volume, surging flow of product to be activated. If that were not the case, they might function in unintended situations, such as when a tank car is being unloaded with the aid of a strong pump. As designed, essentially any apparatus attached to the outside of the external closure valve will create sufficient internal friction (whether hose or pipe) that the flow of product will not be sufficient to activate the excess flow valve. Excess flow valves, by both design and regulation, are intended to function only when the external closure valve is sheared, broken off, or otherwise removed during transit. These devices may also function as a back-up flow control device during tank car loading or unloading activities.
